# Moisture-Tolerant Protective Coating for Low Temperature Application

**BELZONA®**

**5831LT**

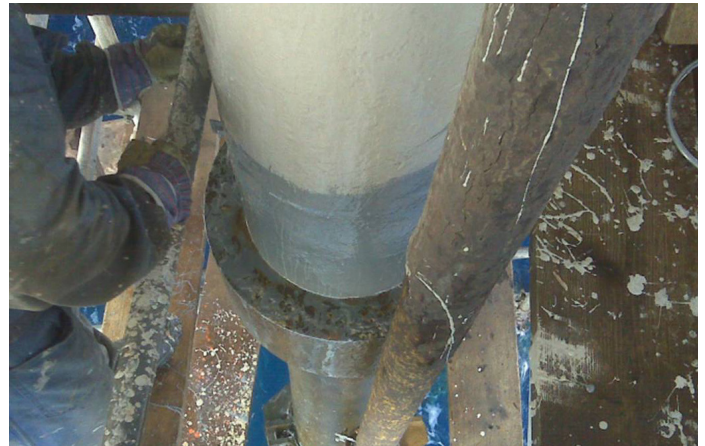
Belzona 5831LT is moisture tolerant and ideal for use offshore
